ROSEBURN PARK SHELTER

FEASIBILITY STUDY

Upgrade/ refurbish disused public toilet and form community shelter

07 December 2012

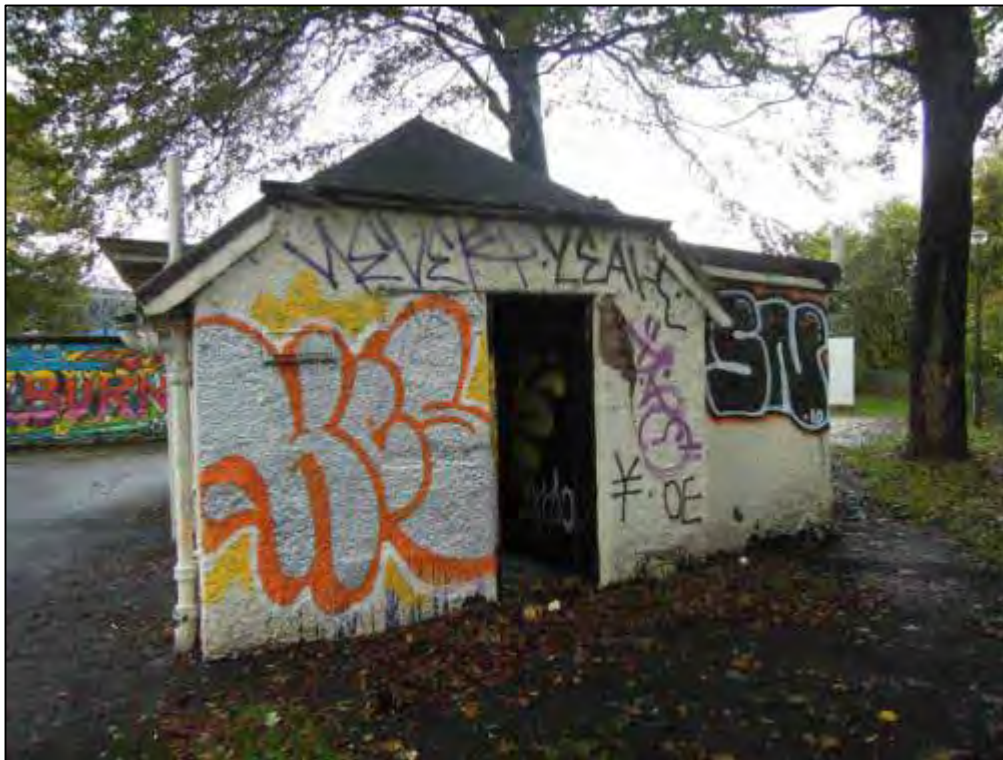
PHOTOGRAPH 4

The building is a solid brickwork construction and is clad with a rough cast render. There are several areas of cracking and spalling to the render with some significant cracking to the brickwork on the North elevation (see Photograph 4).

All external and internal brick walls were reasonably plumb given the age of the structure and free from noticeable settlement other than the cracking to the brickwork on the North elevation. This cracking may be as a result of inadequate propping or lintel bearing when the window was reconfigured and replaced with a door in the 1930s.

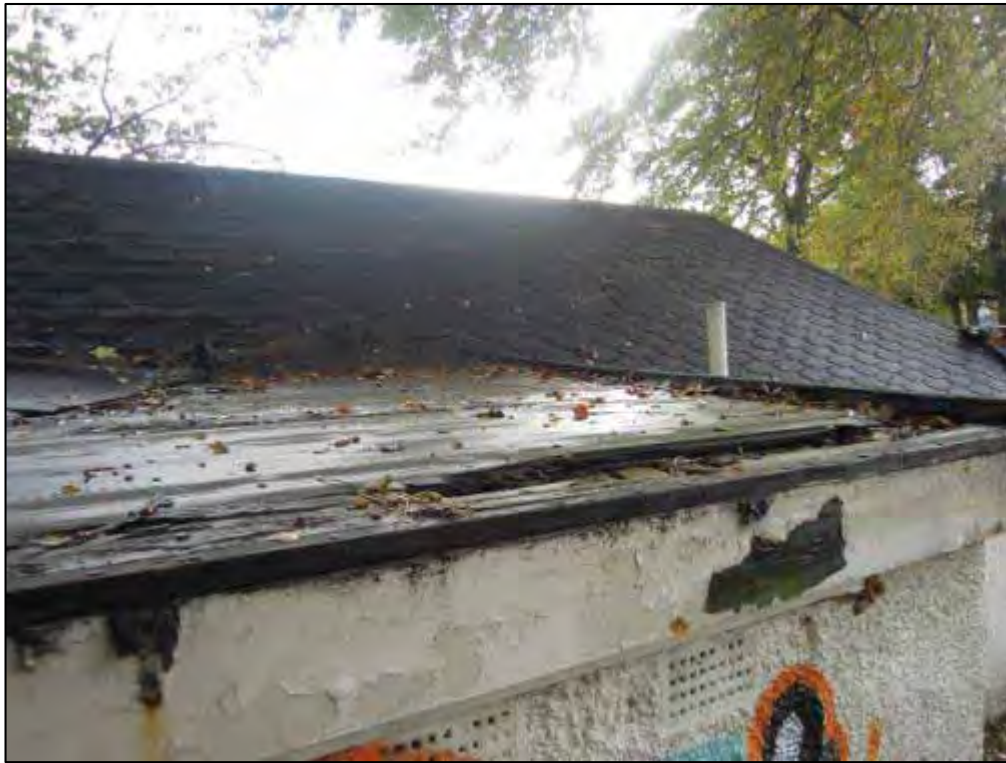
PHOTOGRAPH 19

The water-proofing membrane is almost completely missing from the flat roof above the WC compartments (see Photograph 19) and again water is finding its way into the building where the flat roof meets the wall head and the pitched roof.

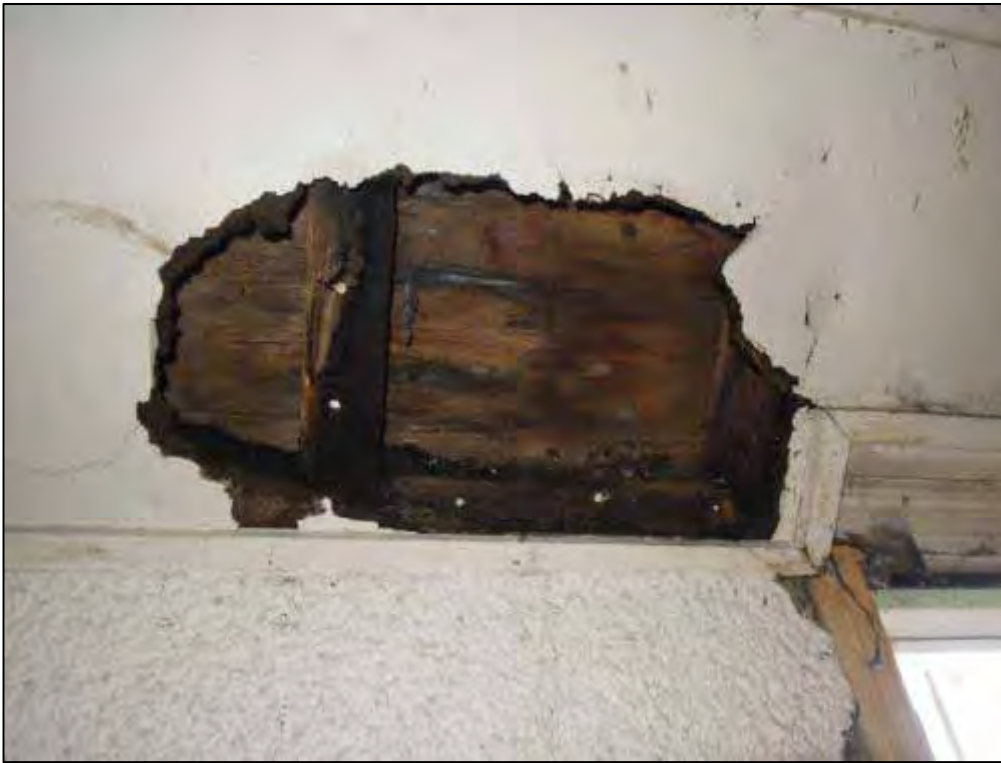
PHOTOGRAPH 27

The roof rafters and timber ceiling joists were generally dry and free from warping, but localised dampness and rot were observed in areas where the roof membrane or flashings have failed (see photograph 27). The external (painted) rafter tails were in good sound condition.

1. Existing ceiling rafters and joists to be replaced or bridled in any areas of water damage or rot.
2. Replace any damaged sarking boards.
3. Form new ceiling above accessible WC and part-hallway. To be strapped with 50x25 treated timber battens and sheeted with 12.5mm t/e plasterboard with vapour control layer behind.
4. Form all new shelving and kitchen units as necessary.

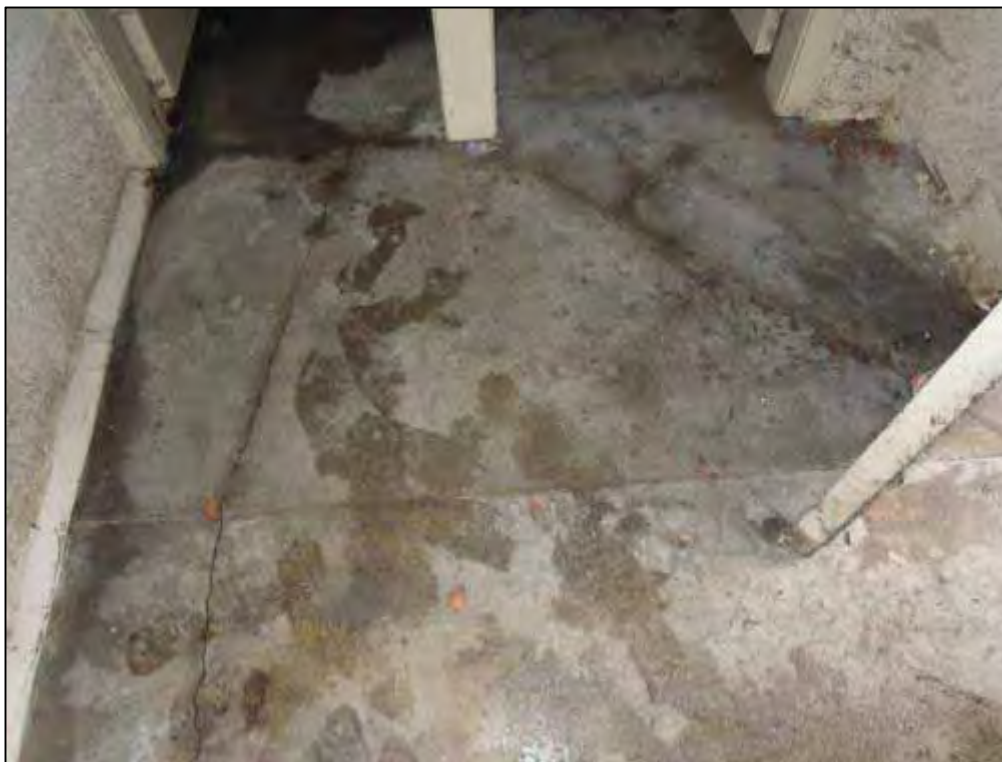
PHOTOGRAPH 30

The building floor consists of a cast in-situ concrete slab which shows some signs of cracking, but generally appears to be of sound bearing (see Photograph 30).

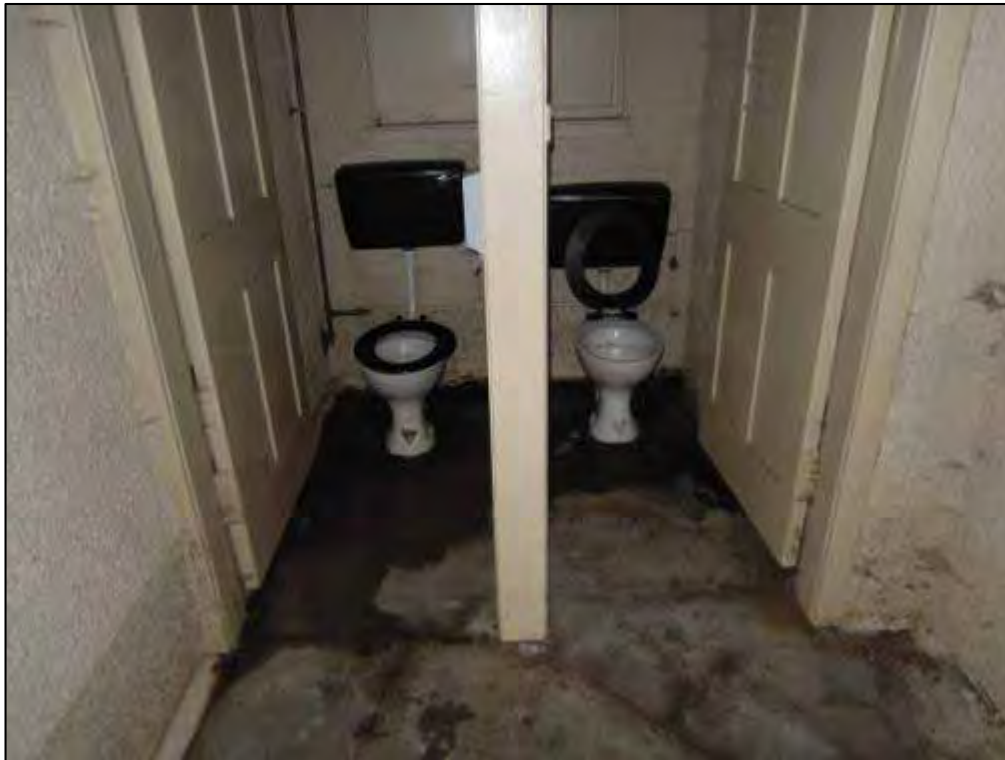
PHOTOGRAPH 31

The pitched roof is clad in a bitumen type tile which has been repaired/ replaced in patches and in some areas is completely missing. The integrity of the roof and any water-proofing membranes is badly affected and water ingress is apparent throughout the building (see Photograph 31).

1. Roof to be overhauled. Roof rafters, joists, sarking boards and fascia to be treated and/ or replaced as necessary, surface waterproofed with tiling under-felt or similar and then finished with traditional roof tiles to match original.
2. Area of flat roof (including canopy on East Elevation) to be finished with suitable waterproof membrane (Green Bauder total roof system or similar) ensuring suitable gradient for rainwater run-off – to roof manufacturer's guidelines; generally 1:80 with 1:40 design slope.
