FEASIBILITY

Project
Roseburn Park Toilet Block
Refurbishment/ cafeteria Proposal

Existing Elevations		
Scale 1:50 @ A3	Date 15 March 2019	By CP
Job No. 1081-FRP	Drawing No. (SK)003	Rev. -

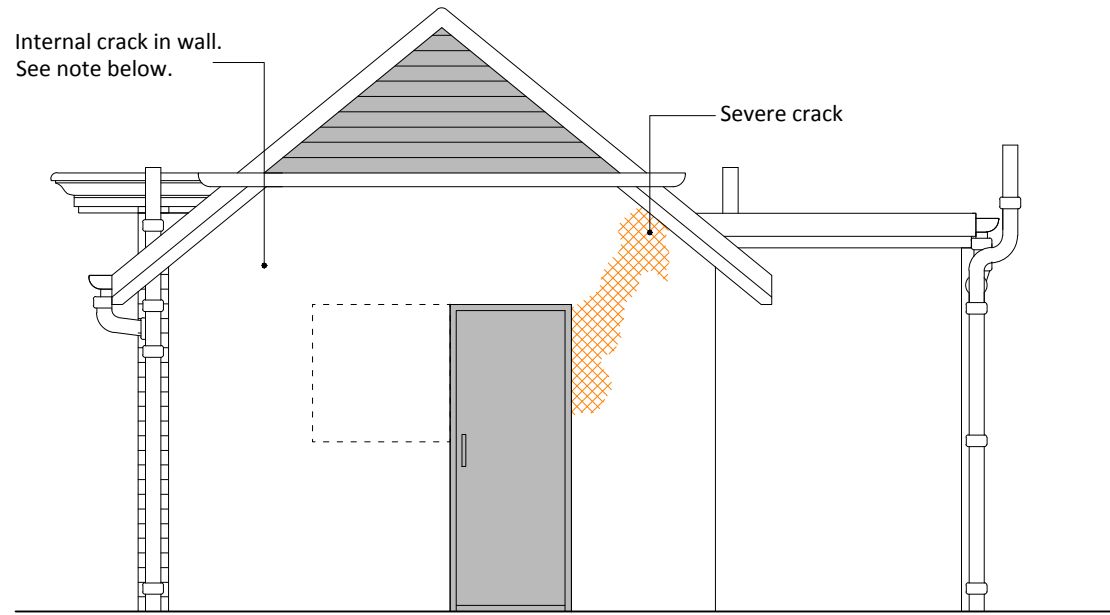
Existing North Elevation
1:50 @ A3

Duntakings

Defective or missing render

If cracks, apparent in render, are found in brickwork, they should be repaired and stabilised with insertion of "Helibar" by Helifix (or similar and approved). Details to be agreed with Designer.

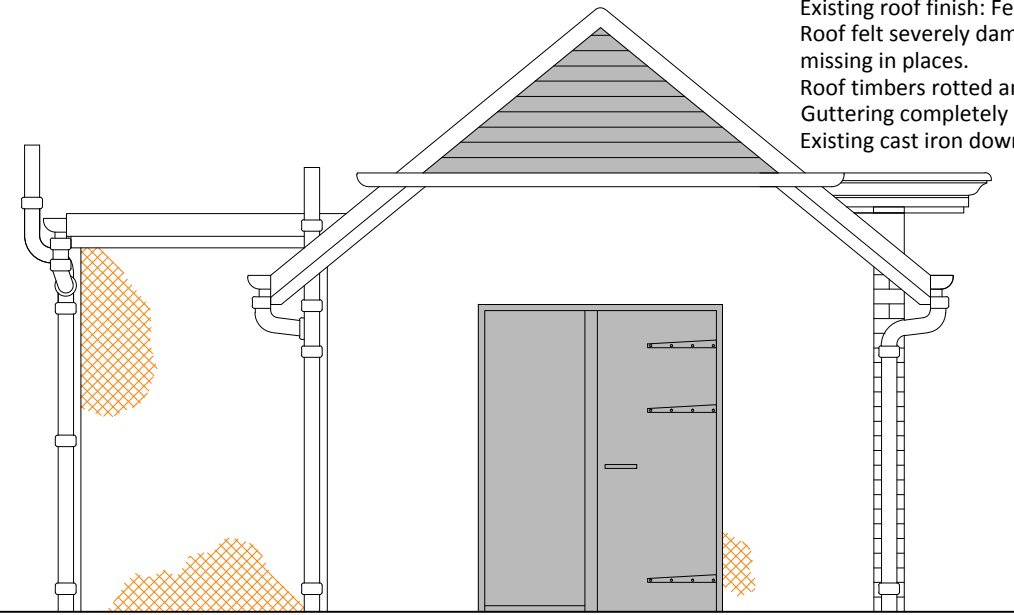
Existing South Elevation
1:50 @ A3

Existing roof finish: Felt shingles.
Roof felt severely damaged and missing in places.
Roof timbers rotted and damaged.
Guttering completely missing.
Existing cast iron downpipes intact.
