ROSEBURN PARK SHELTER

FEASIBILITY STUDY

Upgrade/ refurbish disused public toilet and form community shelter

07 December 2012

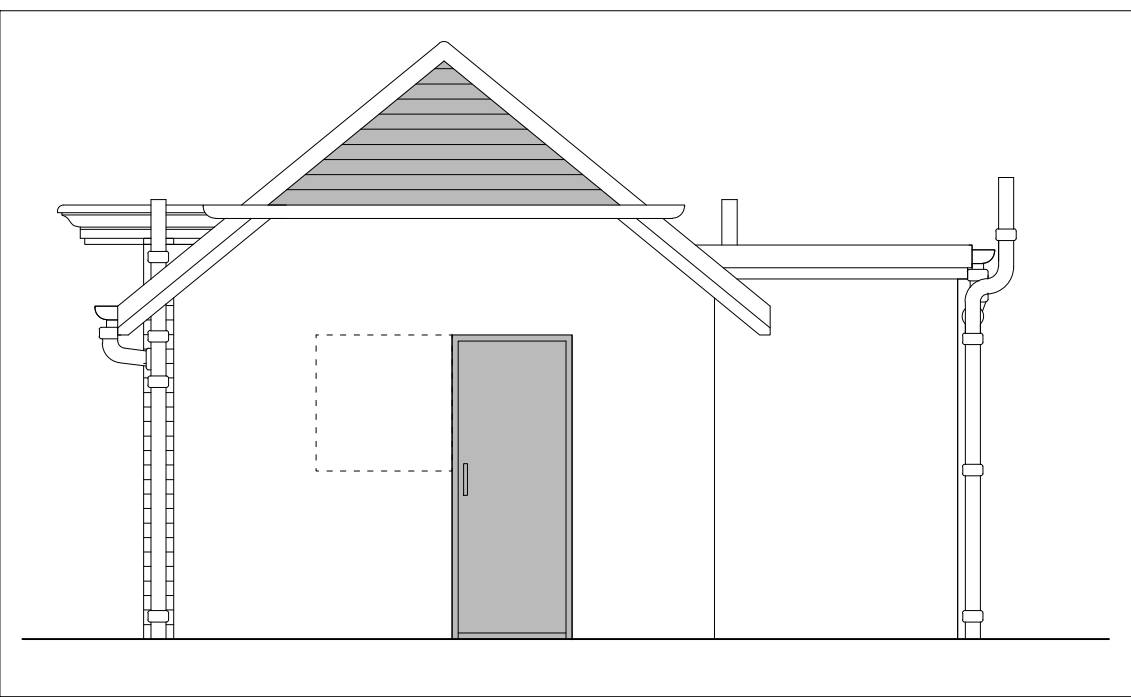
Existing North Elevation
1:50 @ A3

The building is a solid brickwork construction and is clad with a rough cast render. There are several areas of cracking and spalling to the render with some significant cracking to the brickwork on the North elevation (see Photograph 4).

All external and internal brick walls were reasonably plumb given the age of the structure and free from noticeable settlement other than the cracking to the brickwork on the North elevation. This cracking may be as a result of inadequate propping or lintel bearing when the window was reconfigured and replaced with a door in the 1930s.
